Roof Condition Report

9BSE-G - General Services

Intermountain Power Service Corporation
850 West Brush Wellman Road
Delta, Utah

June 2001

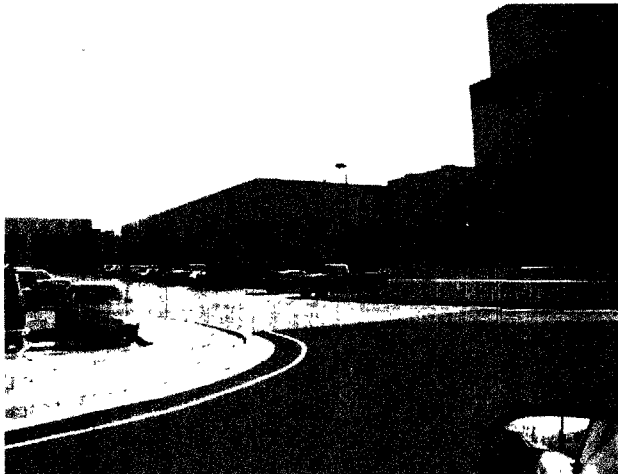
Photo No. 1-G

The northeast corner of the General Services Building, looking southwest. Unit One Boiler is to the right and the Administration Building is to the left.

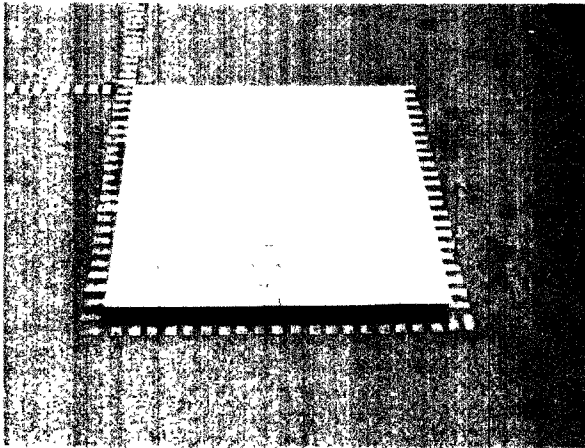
Photo No. 4

A typical skylight, as seen from the Unit One Turbine roof. All of the skylights appear to be in good condition.

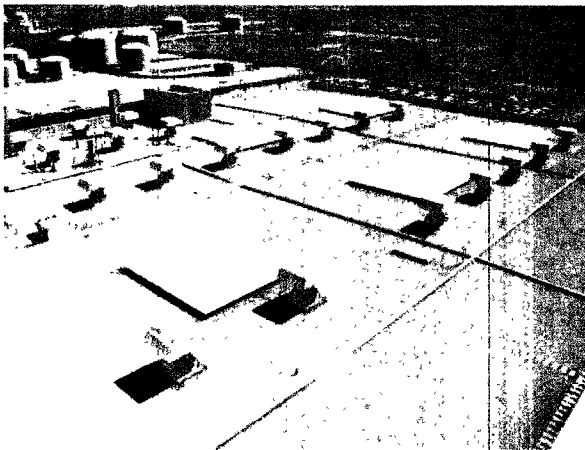
Photo No. 5

The roof of the General Services Building, looking northeast from the Unit One Turbine roof.

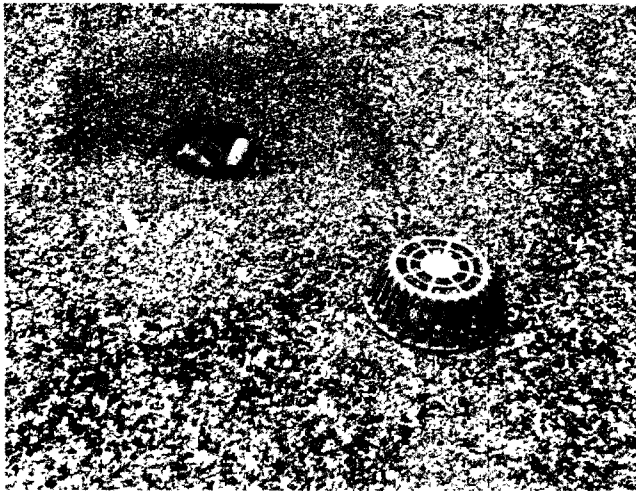
Photo No. 12

Bare area along south wall of building. Roof drain is clogged. Evidence of extensive ponding is visible.

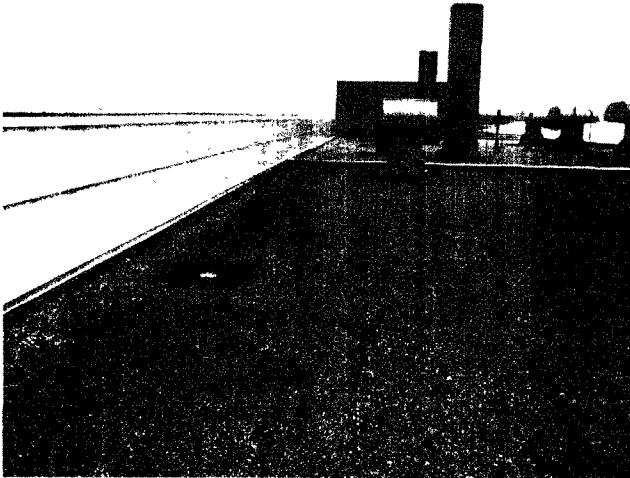
Photo No. 17

Center of roof, looking east. Note the expansion joints covered with foam. Using foam to repair a roof is a reasonable idea, as long as the gravel is removed and the roof power washed with a mild detergent. Maybe the roof drains would be cleared out, too.

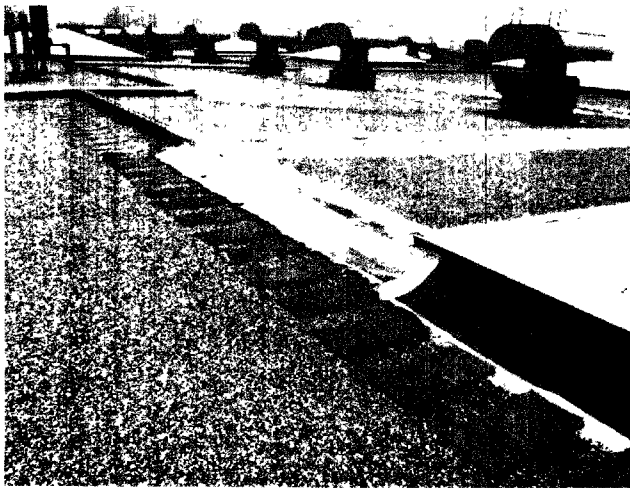
Photo No. 18

Center of roof, looking south. Unit One is to the right. Note the foam on the expansion joints and around the skylight.

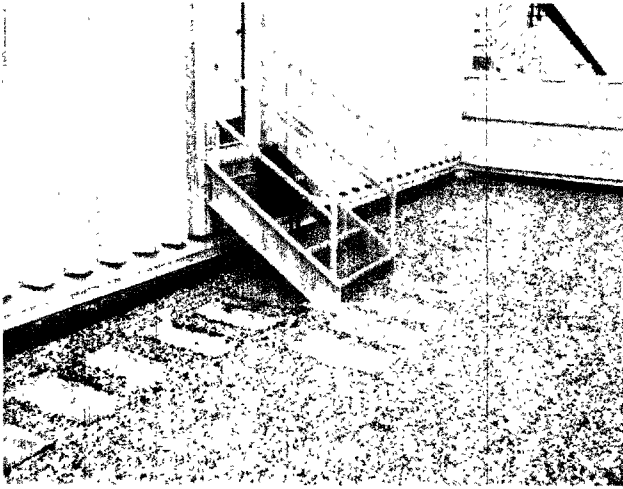
Photo No. 32

Rust on vent equipment. Rust is present in
nearly half of the equipment.

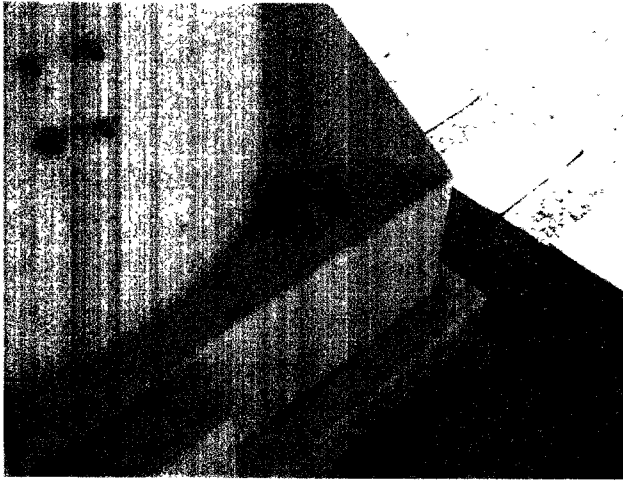
Photo No. 33

Expansion joint in center of roof, looking
west. Note the foam over the joint and
around the equipment. Three attempted
patches are shown in the photo. The
orange foam has lost the acrylic coating
and is severely damaged by the UV rays of
the sun. The drain pan is almost filled with
gravel.

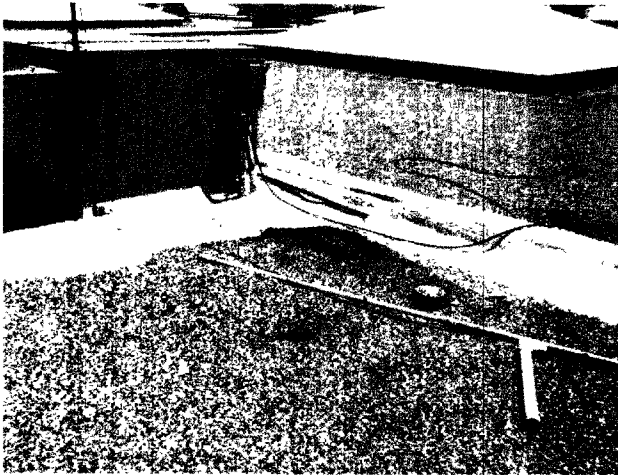
Photo No. 34

Opposite end of equipment shown in Photo No. 71 above. Damage to the foam is shown in the center of the equipment. Note the TV antennae on the ground.

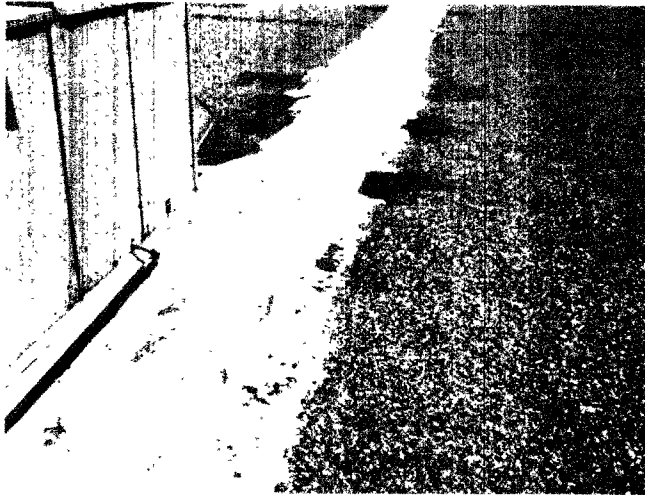
Photo No. 37

Foam over expansion joint. Attempted repairs are shown on both sides of the expansion joint. Equipment is shown in Photos 71 & 72. The orange showing in the foam is exposed foam not covered by surfacing. UV rays from the sun damage the foam very quickly if it is not protected by the acrylic coating.

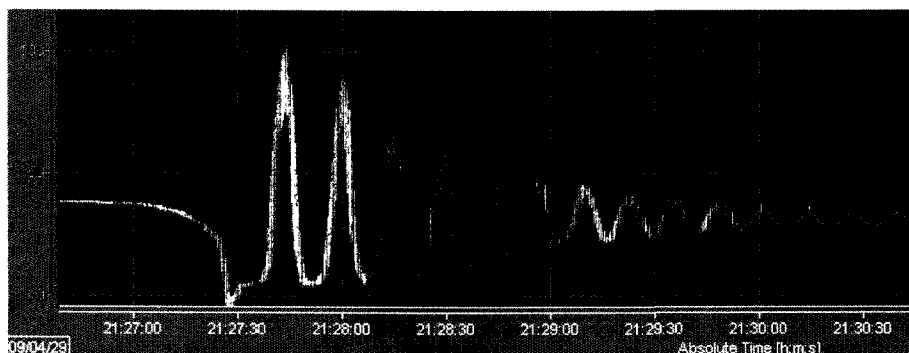
Pressure probes and a data logger were installed at the DMAD pump station shortly after the 2008 line break. The data has been gathered after significant changes to system flow in order to gain an understanding of the cause and severity of transient events. Figure 1 below shows a transient event recorded in April 2009.

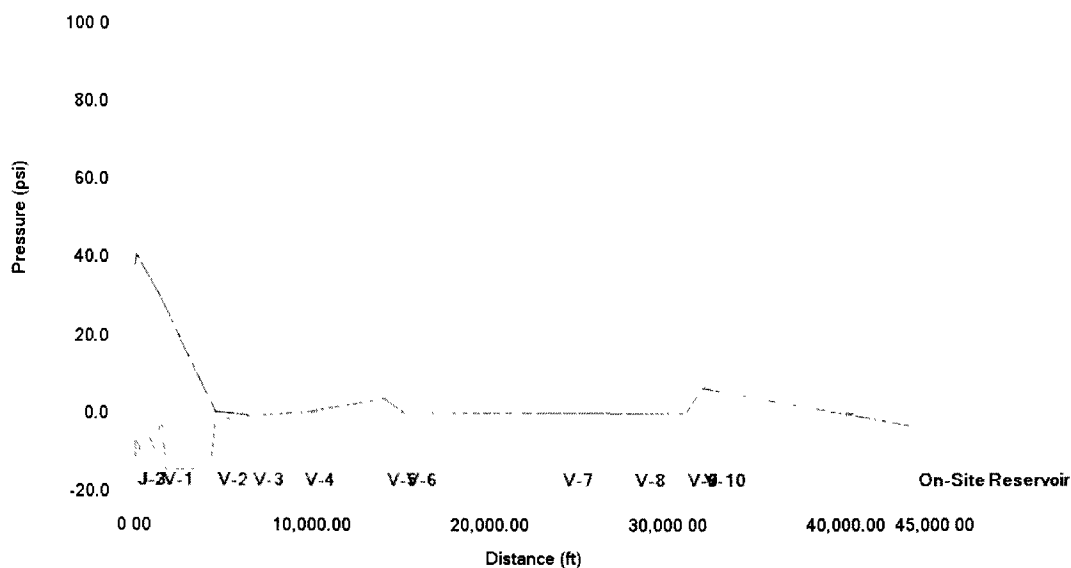
Figure 2

The model has been calibrated to mimic the transient event shown in Figure 1. Figure 2, below, shows the results of a two-pump power failure simulated by the modeling software. The results are reasonably similar and provide a good representation of the system. This model facilitates testing to determine the probable worst case as well as transient protection alternatives.

It is interesting to note the modeled pressure at the location of the 2009 pipe failure (approximately 500 feet from the pump station) of approximately 85-90 psi. This is above the hydrostatic test pressure of just 75 psi.
